The road and hurdles towards GEP for large rivers in the Netherlands

Fred Wagemaker (RWS) &
Tom Buijse (Deltares)

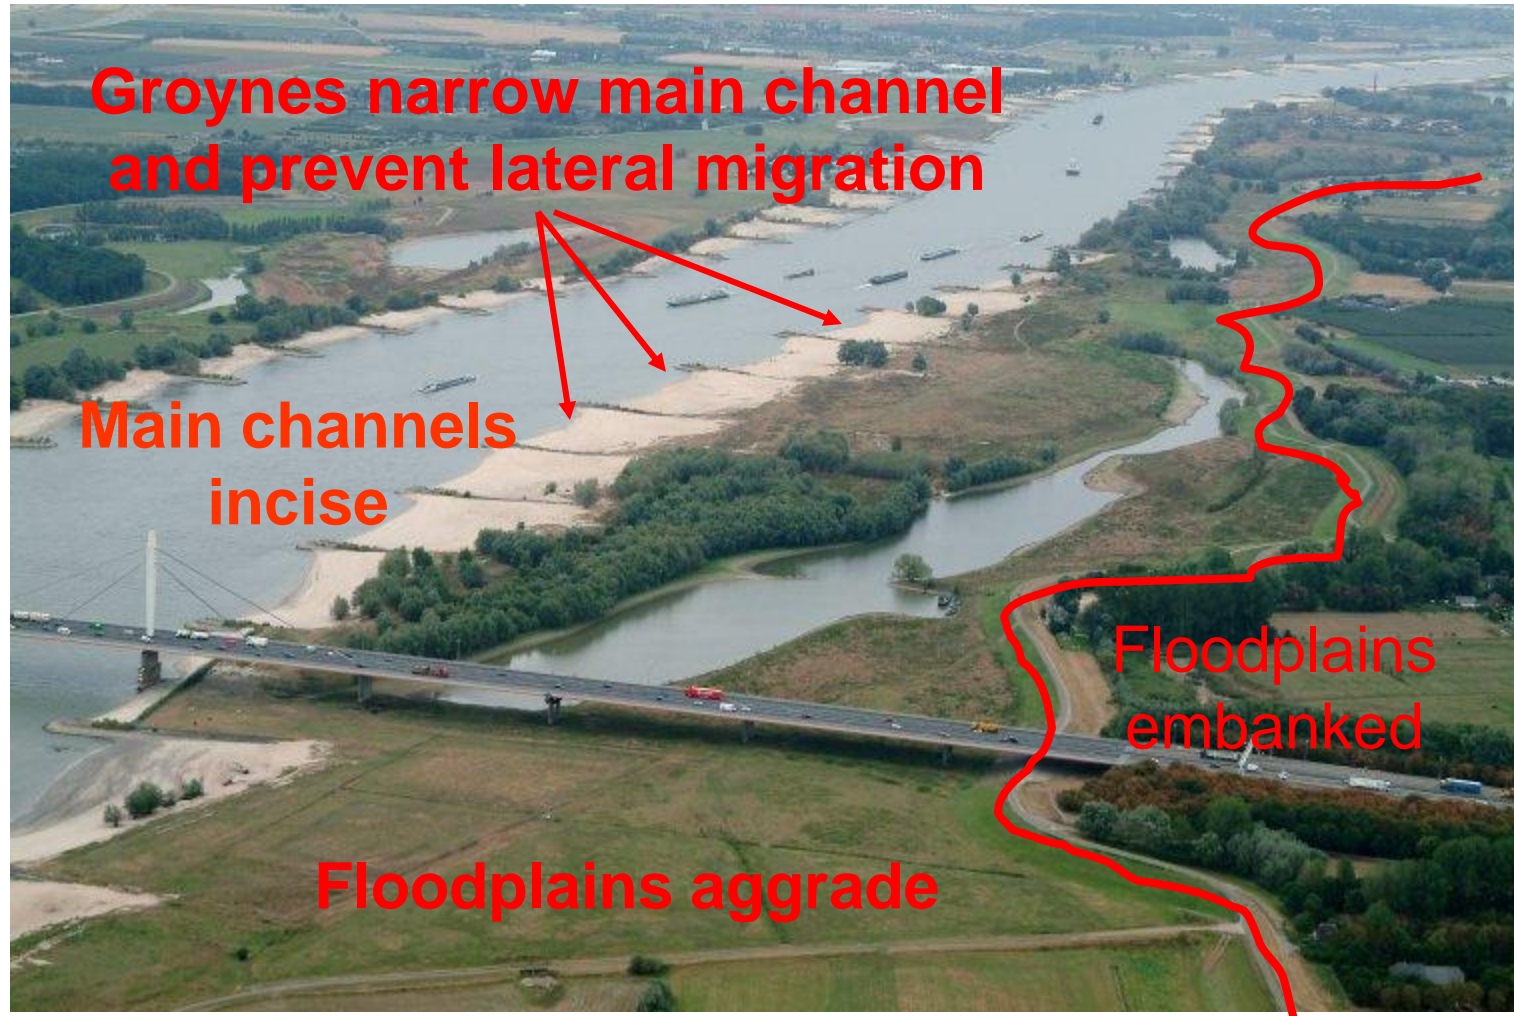
Rivers : Many hydromorphological pressures

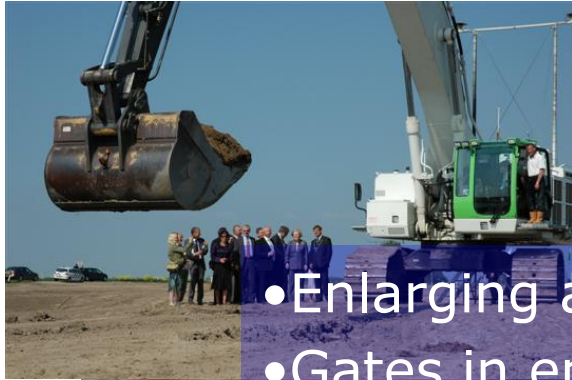
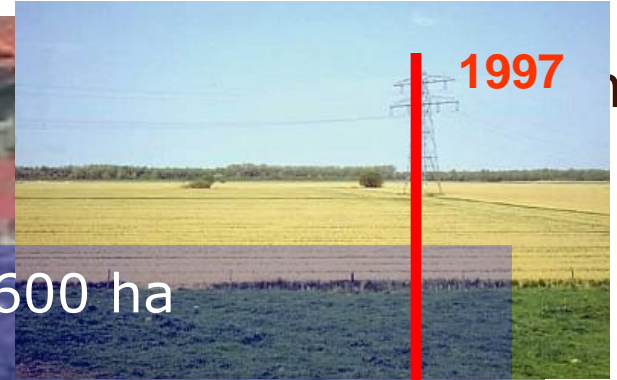
- Enlarging active floodplains with 600 ha
- Gates in embankments
- Flooded several times per year
- Sparsely populated -> individual houses protected
- Agriculture -> Nature Freshwater tidal channels
- Official start May 2008 (Crown Prince, Minister, Mayor) -> significance of the project

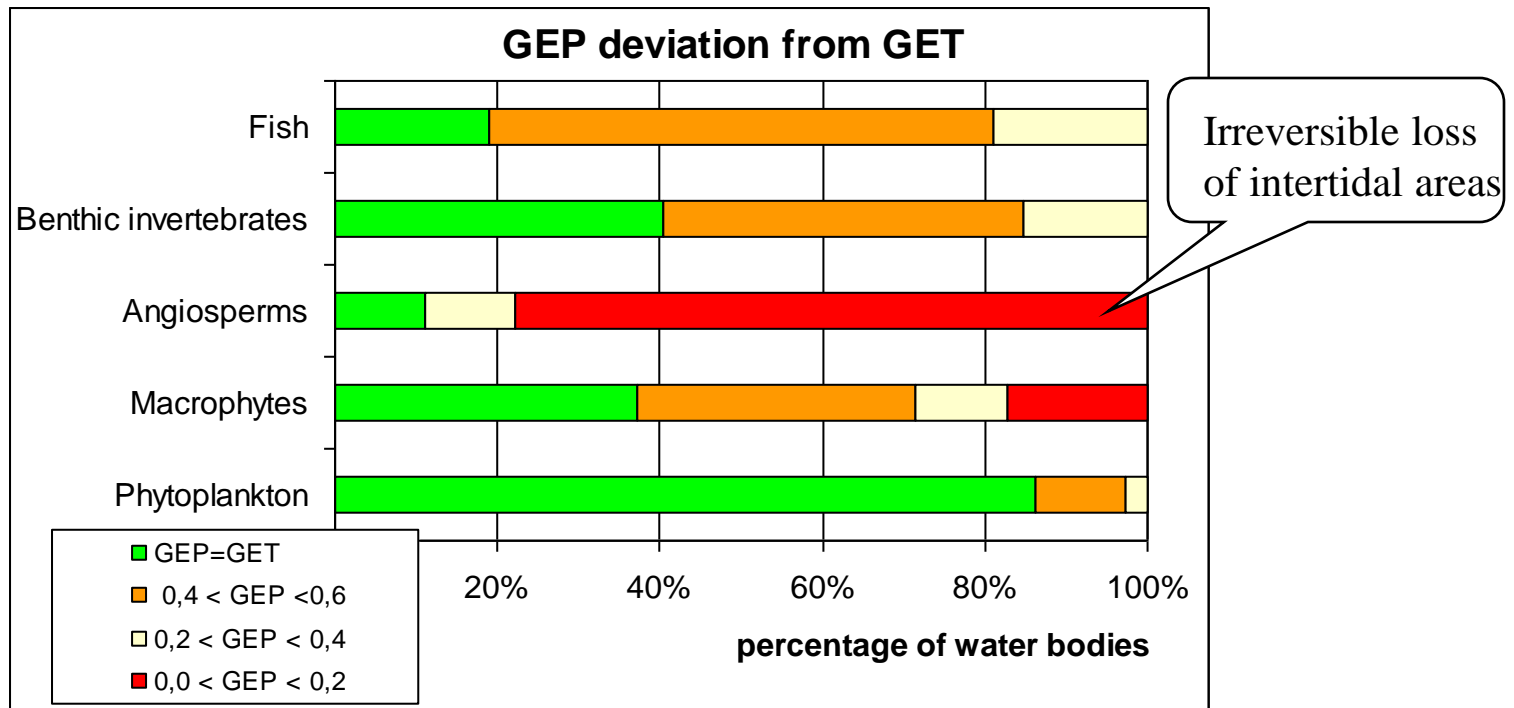
Overall: GEP does not deviate a lot from GET

One out, all out: per waterbody there is mostly a BQE that cannot meet GET
